Could Zinc Whiskers Be Impacting Your Electronic Systems? Raise Your Awareness

Jay Brusse
QSS Group, Inc.
Greenbelt, MD
Jay.A.Brusse.1@gsfc.nasa.gov

Michael Sampson
NASA Goddard Space Flight Center
Greenbelt, MD
Michael.J.Sampson@nasa.gov

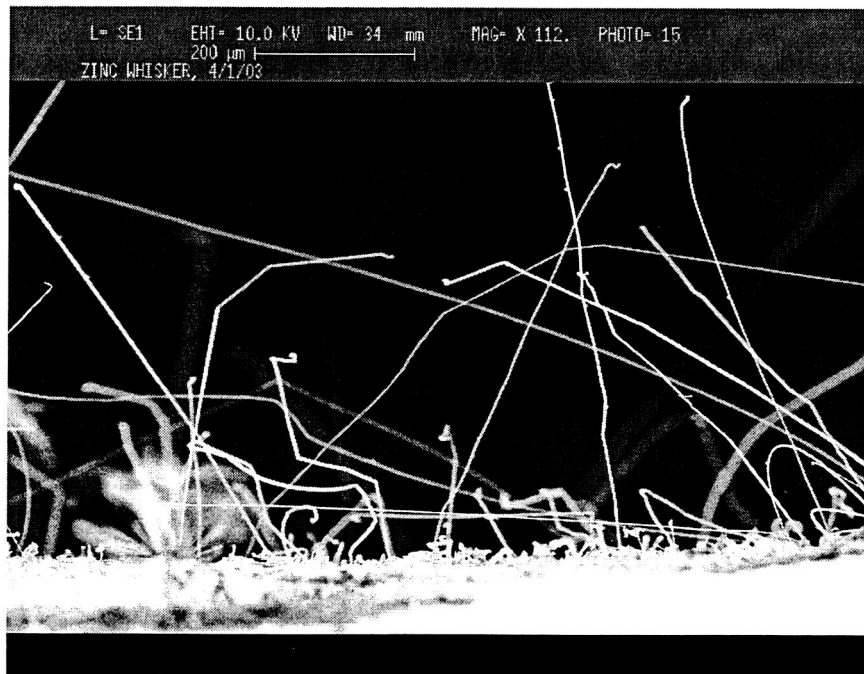
Figure 1: Zinc whiskers found growing from bottom of an access floor tile (~100x). Many have lengths on the order of 1 mm or more.

Zinc whiskers (Fig. 1) are tiny conductive filaments of zinc typically less than a few millimeters (mm) long and only a few thousandths of a millimeter in diameter. They may grow from some metal surfaces (e.g., steel) that have been coated with zinc (especially by electroplating processes) for corrosion protection. The growth process consists of an unpredictable incubation period lasting months or perhaps even years followed by a period of growth at rates as high as 1 mm/year. Due to their miniscule diameter, zinc whiskers can be extremely difficult to see without magnification and/or proper illumination techniques.

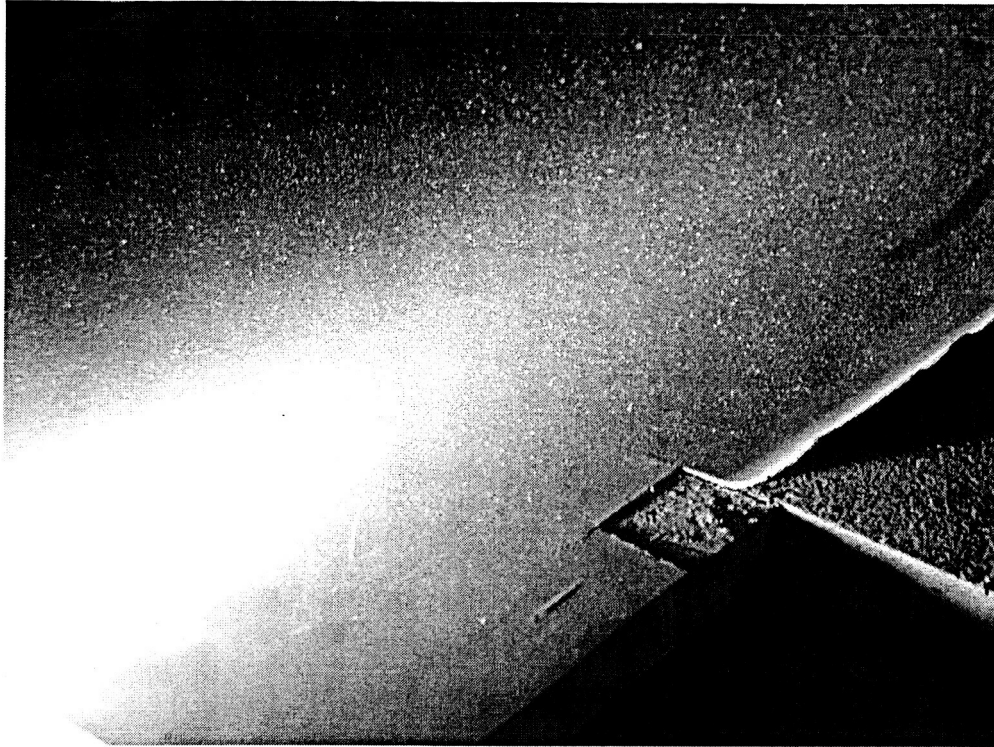
Raised floor tiles, pedestals and stringers are often constructed of steel to provide good structural integrity. A thin zinc coating applied either by electroplating or hot dip galvanization (HDG) is commonly used to protect the steel from corrosion. It is this thin zinc film that is at risk of forming zinc whiskers over time especially (though not exclusively) for those films applied by electroplating processes. Figure 2b shows one type of access floor tile that has been observed to have zinc whiskers. Figure 3 shows the underside of this tile which when examined using high intensity light shined parallel to the surface reveals what appears to be fuzzy, dust-like formations. Closer examination reveals that the dust-like appearance is actually millions of zinc whiskers shown in Figure 1.

Figure 3: UNDERSIDE of zinc-electroplated steel access floor tile shown in Figure 2b. The sparkling "dust-like" appearance on surface is actually millions of zinc whiskers (shown magnified in Figure 1)

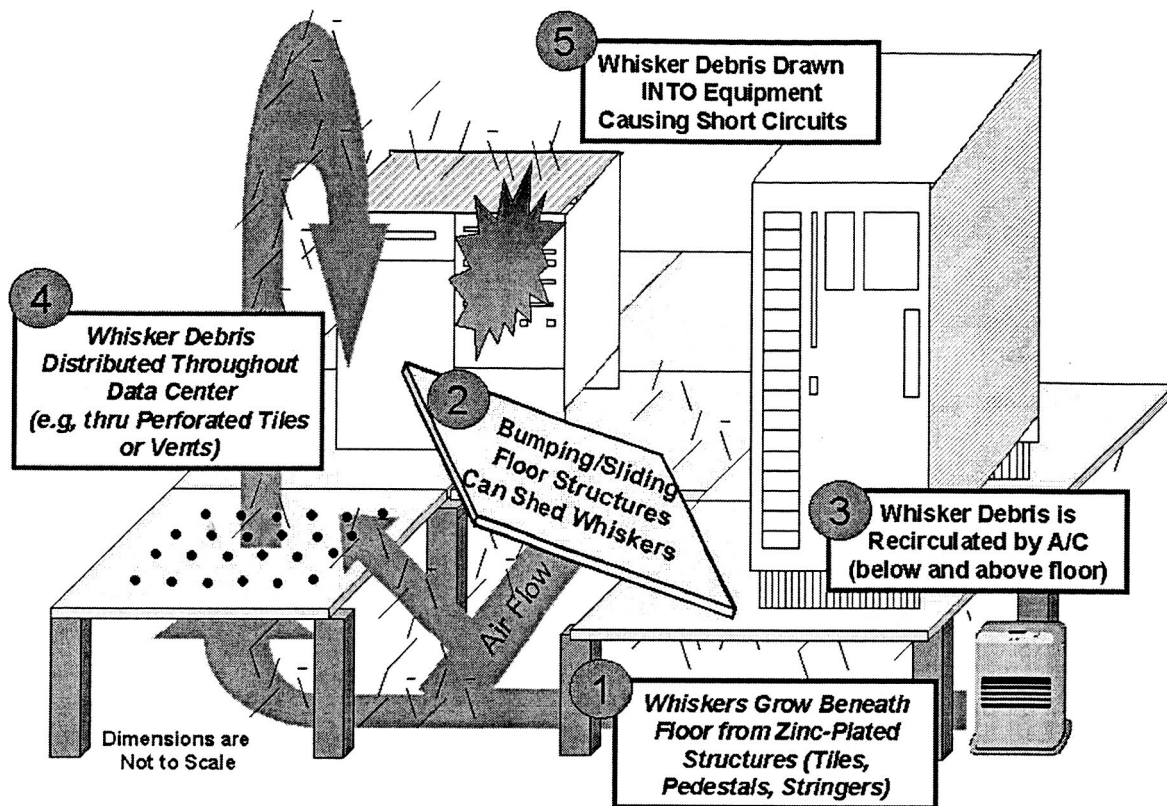
The review further determined that the zinc whiskers were most likely dislodged from the floor structures during the floor handling/bumping activities involved in the new equipment installation. Subsequently, loose zinc whiskers became entrained in the data center airflow with some ultimately being deposited inside the affected equipment where they were able to induce the observed electrical short circuits. Zinc whiskers growing on the underside of raised floor structures may seem to be a long distance from electronic systems that are operating above the floor. However, experience has demonstrated that floor-bumping activities such as lifting, sliding and reinstallation of access floor tiles and pulling of electrical cable in the sub-floor space can dislodge whiskers from their point of origin. Because of their small size and weight, zinc whiskers are easily redistributed throughout the facility via the forced air-cooling. The sub-floor space in raised floor facilities is commonly pressurized with chilled air to provide efficient cooling. Perforated floor tiles and air vents provide channels through which the cool air and along with it, zinc whiskers, can be blown into the above floor space. Ultimately, many whiskers may be drawn inside of electronic hardware through vents and fans on the equipment. Once inside the equipment zinc whiskers may cause a variety of electrical failures ranging from intermittent to permanent short circuits. Whisker debris may also become a physical impediment to moving parts or obscure optical surfaces and sensors within some equipment (e.g., disk or tape drives). Figure 4 shows a graphical representation of the zinc whisker failure mechanism as it pertains to raised floor facilities.

Figure 4. Graphic representation of the mechanism by which zinc whiskers growing on raised floor tiles, pedestals or rails can be distributed throughout a data center
